MARCHANTS CROSS, MEAVY.

BY R. HANSFORD WORTH.

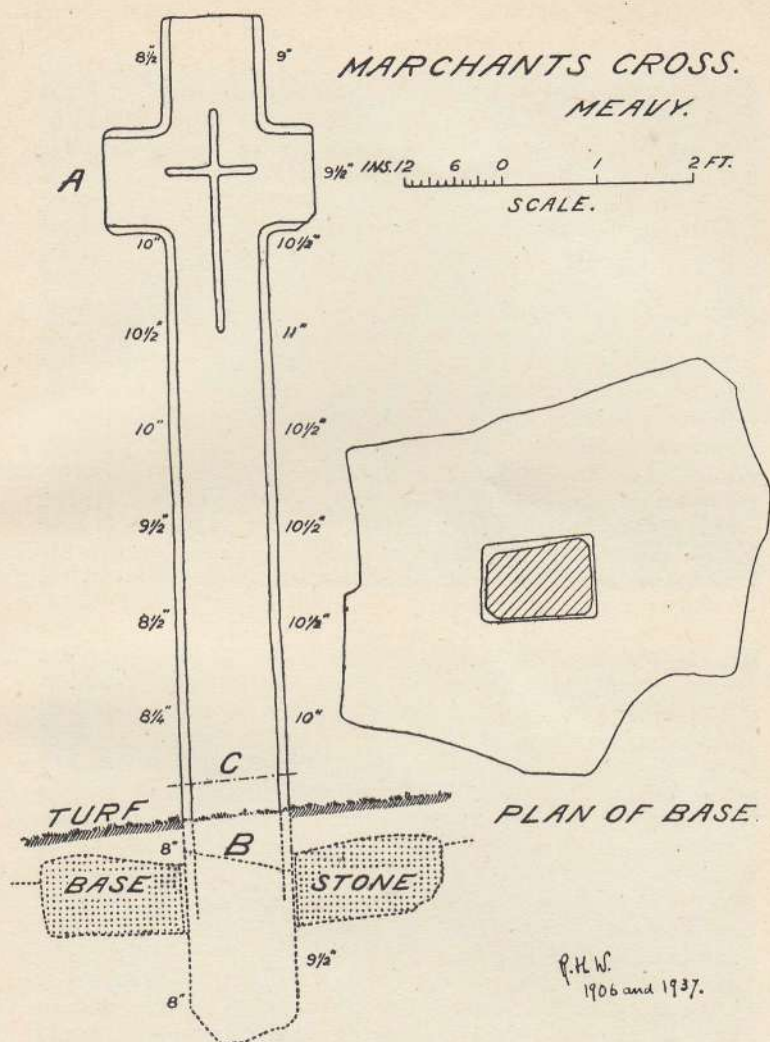
DETAILS OF MARCHANTS CROSS.

Always, within living memory, the cross had risen (to a height of 8ft. 4ins.) from a surface of greensward. It broke at a depth of six inches below the surface, as indicated by the dotted line "B" on the figure in the text. No other fracture or flaw could be found.

From the manner in which the break occurred it seemed probable that the shaft was in some fashion held at or near that level. By lifting the turf a base was disclosed, consisting of a very irregular slab of granite, with a socket cut completely through it. Except for the socket this base was wholly unworked, and it was probably not intended to be seen. The shaft of the cross went through the base and fourteen inches into the ground below. The broken stump was withdrawn, the hole in the ground partly filled with concrete, and the cross reinserted in the base-stone up to the dotted line "C" on the figure. The turf was lifted, the upper surface of the base exposed, and the surrounding ground lowered somewhat. The base has been left exposed, and the cross now stands 7ft. 11½ins. in height, having lost 4½ inches in visible length of shaft. But the top is really ten inches below its original level.

It may be of interest to record that the original total length of the cross was roft. 8ins. The figures beside the shaft on the drawing indicate the thickness of the stone. The arm marked "A" is to some extent defective on the other face, but that defect may be original.

The Ordnance Surveyors have, or had, a flair for disfiguring ancient monuments, and had cut a bench mark on the shaft at the level of 519.0 above datum. In consequence of the necessary shortening of the shaft that bench mark now indicates 518.17 above datum. The shaft was shortened by the length of the broken stump because the stone at that end was not found to be fitted to take a dowel, and the broken parts could not be safely rejoined. The stump has been preserved at Meavy Church.

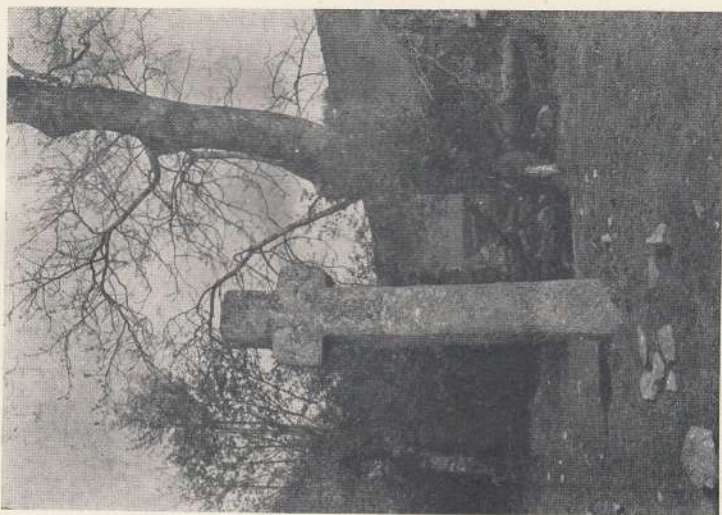
Fig. 1. MERCHANTS CROSS, 26/4/1890.

By way of record I have prepared Plate (8), on which Fig. 1 is a view of Marchants Cross as it stood fifty and more years ago, and Fig. 2 shews the cross as re-erected.
